GEO-HAZARDS DURING EARTHQUAKES AND MITIGATION MEASURES

- LESSONS AND RECOMMENDATIONS FROM THE 2011 GREAT EAST JAPAN EARTHQUAKE-

(Digest Version)

The Japanese Geotechnical Society

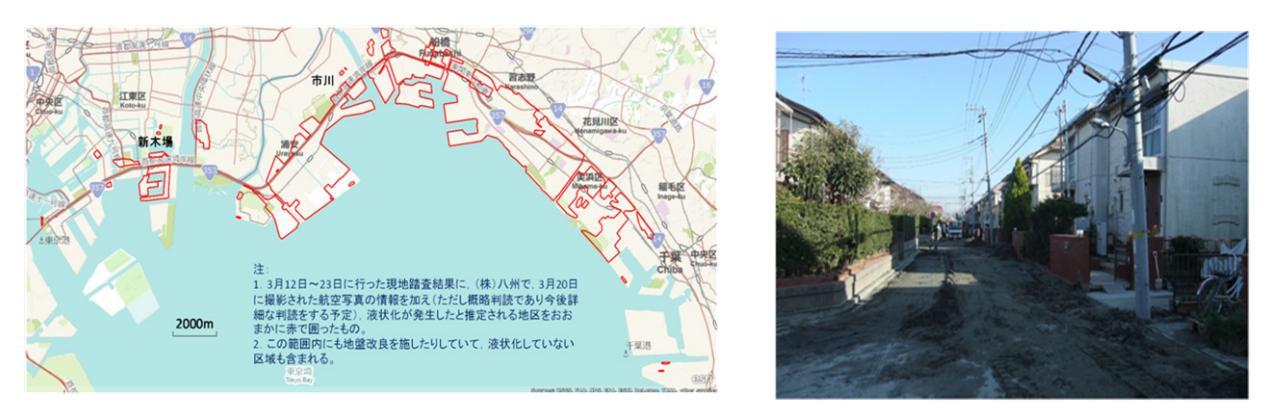
Fig. 1 (left) Estimated liquefied zones (delineated by red lines) along Tokyo Bay (Yasuda, S. & Harada, K.) Fig. 2 (right) Damaged houses and road due to soil liquefaction (Yasuda, S.)

Soil liquefaction widely made significant damages on a great number of structures in Tohoku and Kanto areas. The range of distances from the epicenter to damaged areas is consistent with that in the experiences of the past earthquakes both at home and abroad. Yet, vast areas of recently reclaimed lands in the Tokyo Bay area were damaged by soil liquefaction, though these areas are as far as 380 km away from the epicenter (Fig. 1). In the Tokyo Bay waterfront areas, over ten thousands houses suffered from serious settlements or inclinations due to soil liquefaction. Lifelines such as sewage lines and roads were also damaged severely. In the alluvial lowland of the Kanto Plain, many similar damages were observed in recently reclaimed lands on lakes and former channels. Furthermore, soil liquefaction took place in some parts of the developed housing lands on hills in Tohoku area. In Tohoku and Kanto areas, many river dikes were also damaged seriously by soil liquefaction in foundation ground (mostly located in old river channels).

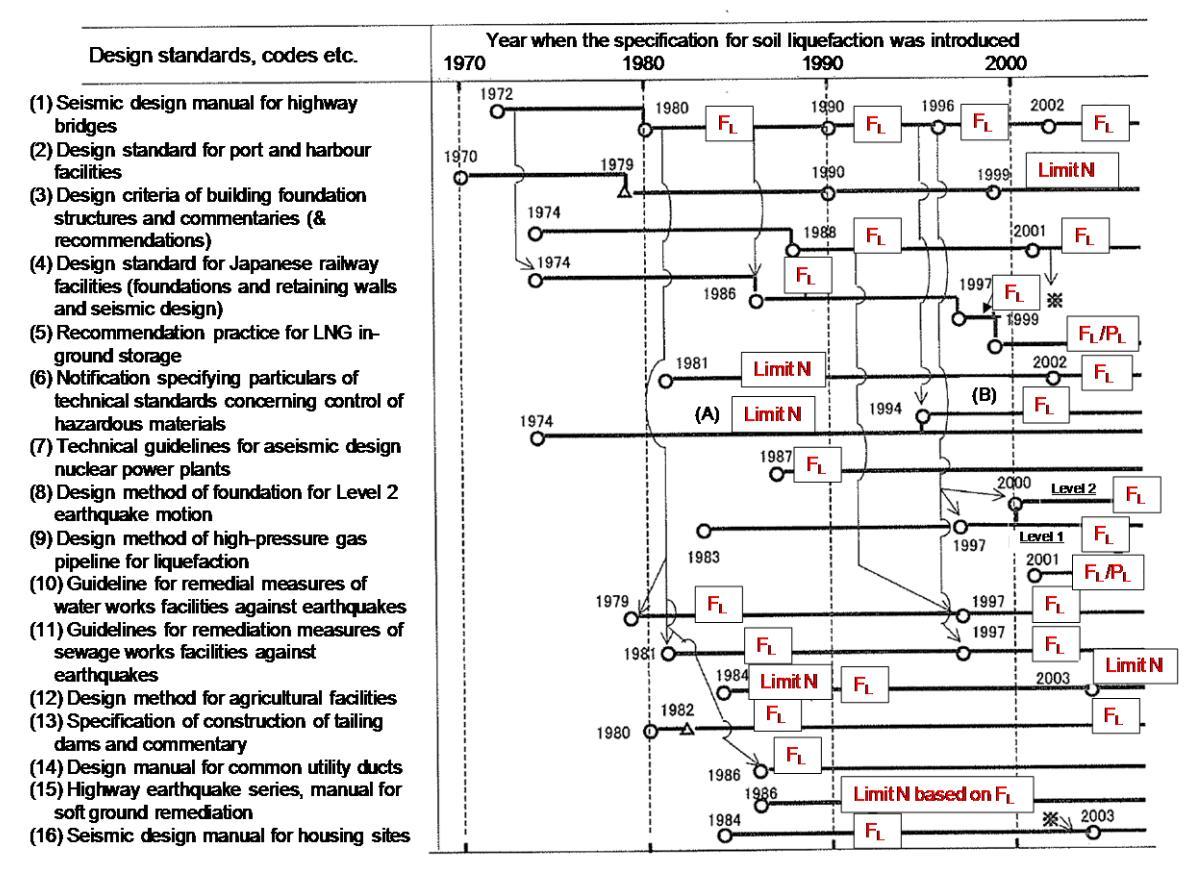
Fig. 3 History of introduction of the specifications for prediction of and countermeasures against soil liquefaction in Japanese design standards and codes for infrastructures

FL: the method to predict the safety factor against soil liquefaction of a soil element based on "the Liquefaction Resistance Factor

(F1)" of the soil element, which is obtained by dividing the "strength with respect to soil liquefaction" by the

"liquefaction-inducing seismic load acting on the soil element.")

PL: the method to predict the soil liquefaction potential of a given strata based on "the Liquefaction Potential Index (PL)", which

represents the degree of liquefaction predicted for the whole of a given strata obtained from the vertical distribution of F_L value.

Limit N: the method of soil liquefaction prediction based on "the limit value of N (the number of blow count by the standard

penetration test".

- (A) : Oil tanks designed following the design code established 1974
- (B) : Oil tanks constructed before the year of 1974.

Level 1 and Level 2: Design seismic load levels for which soil liquefaction is predicted

The above is because those public structures are designed and constructed under the technical standards which consider influence of soil liquefaction. Having experienced the Niigata Earthquake in 1964, geotechnical engineers have recognized risk of soil liquefaction. And then, the relevant seismic design codes for public facilities have been revised to consider prediction and countermeasure of soil liquefaction (Fig. 3). These improved seismic design

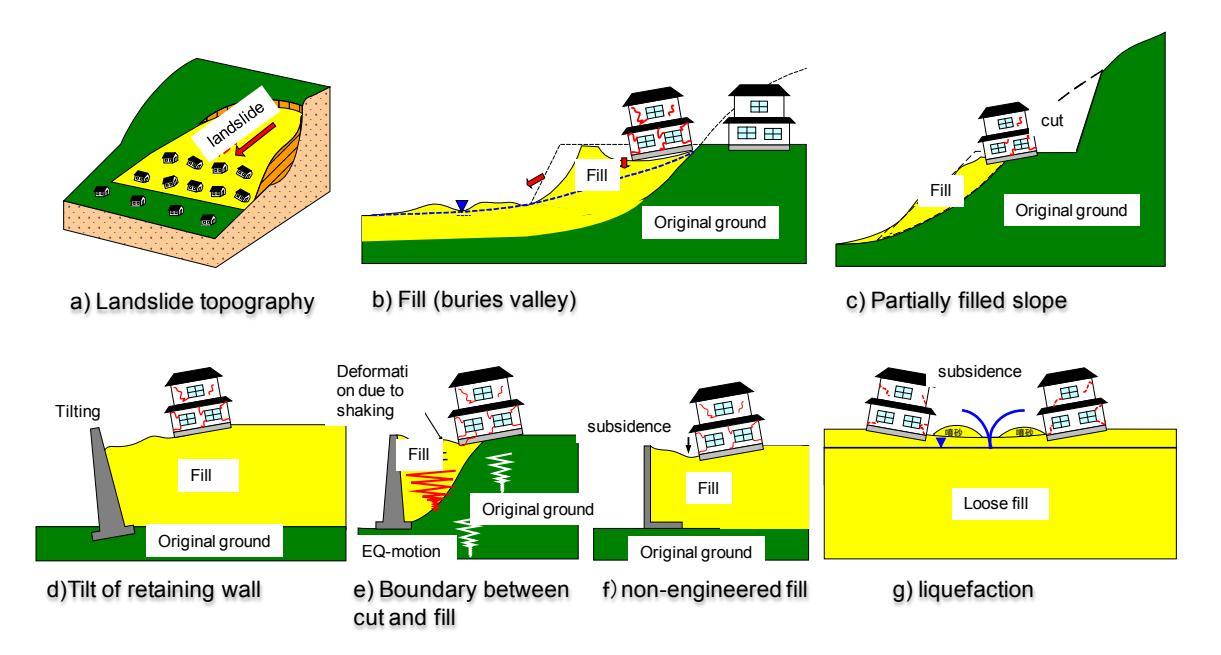
Fig. 4 Classification of damage mechanism of residential fill ground (Kazama, M.)

The earthquake damage mechanisms of residential fill ground can be classified into the types shown in Fig. 4. Of these, there was nearly no large-scale damage to residential land due to type (a), where slope failures are similar to landslide of natural grounds with sliding surface. On the other hand, there was a number of large-scale damage caused by type (b), where damage typically took place in the slopes of filled valleys. Differential settlements of houses are observed in many places on the boundary between cutting and filling as type (e) and on embankment as type (f). The last two types are thought to have resulted from the long duration of the earthquake motion. Fig. 5 is a photograph of typical case of type (b) damage.

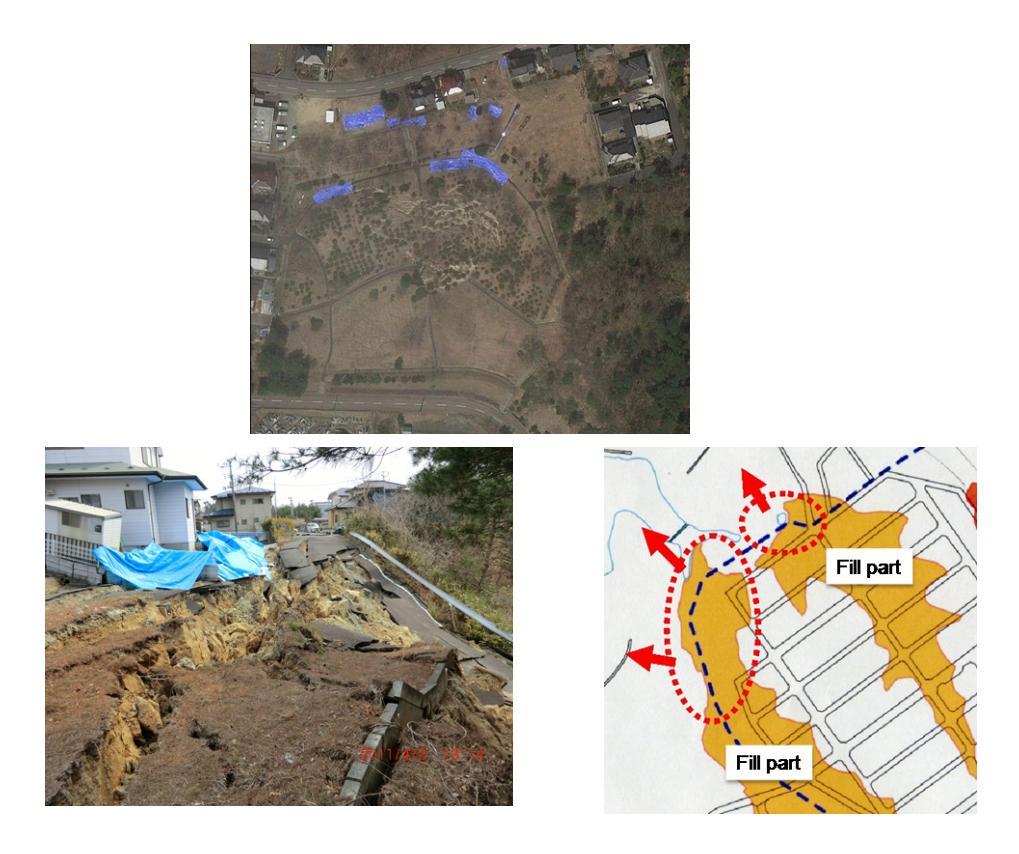
a) Re-damaged residential fill ground that had been damaged by the 1978 Miyagiken-oki Earthquake, Shiroishi City, Miyagi Prefecture

b) Another typical damage case of embankment in narrow valleys, Yamamoto, Miyagi Prefecture

c) Location of damage case shown in the middle figure in the plan view at the site

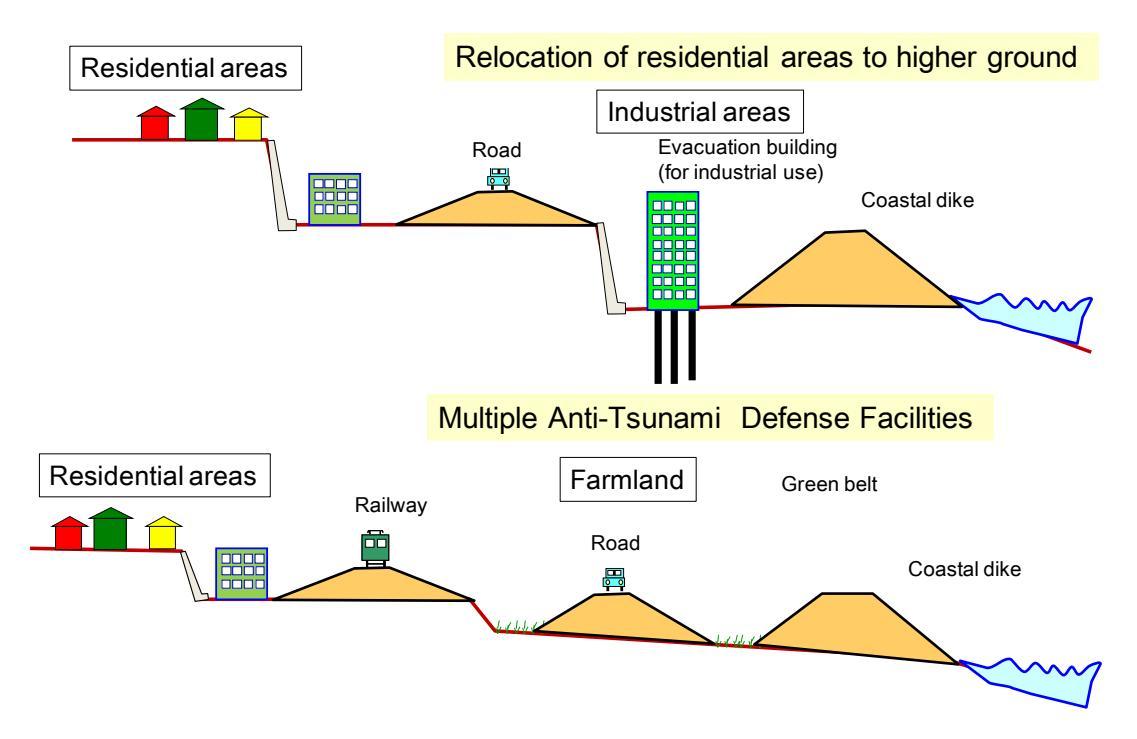
Fig. 6 Schematic diagrams showing applications of conventional geotechnical technologies to the restoration program (the first version) of Miyagi Prefecture (Asahi Newspaper, morning paper, 4th June, 2011)

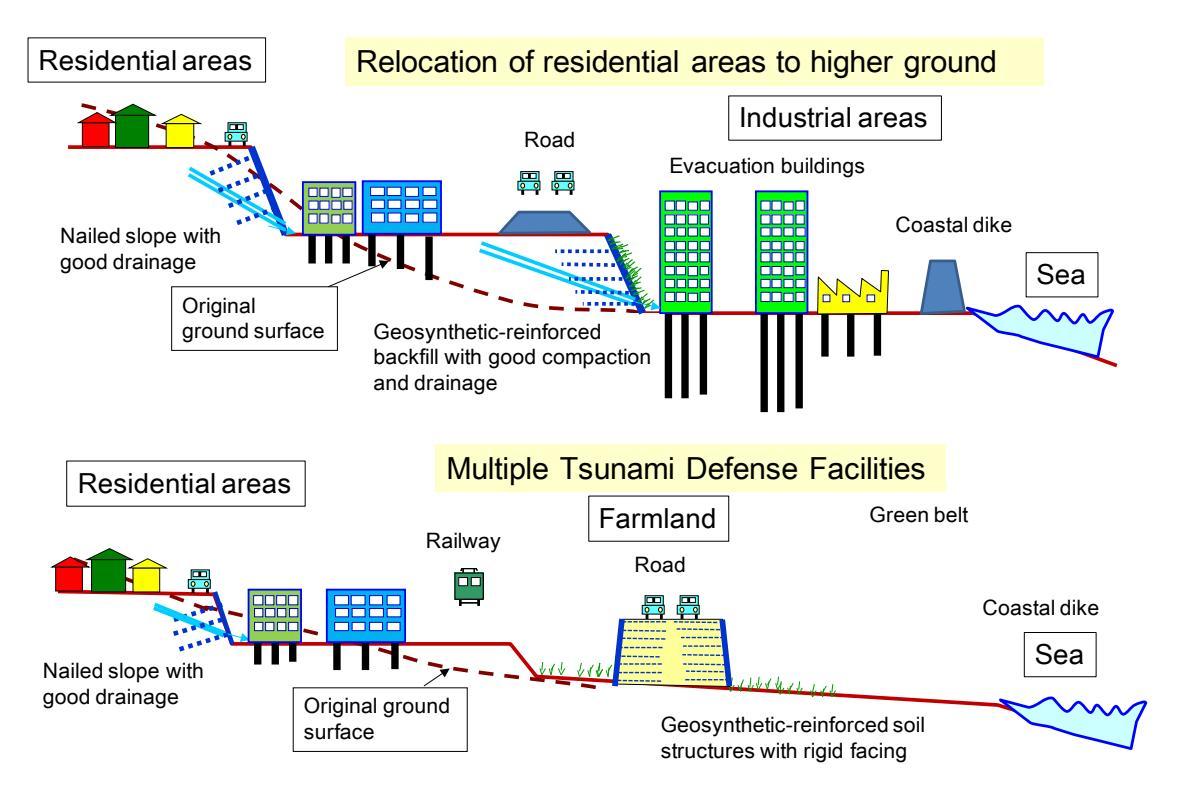
Fig. 7 Schematic diagrams showing applications of recent geotechnical technologies to the restoration program (the first version) of Miyagi Prefecture

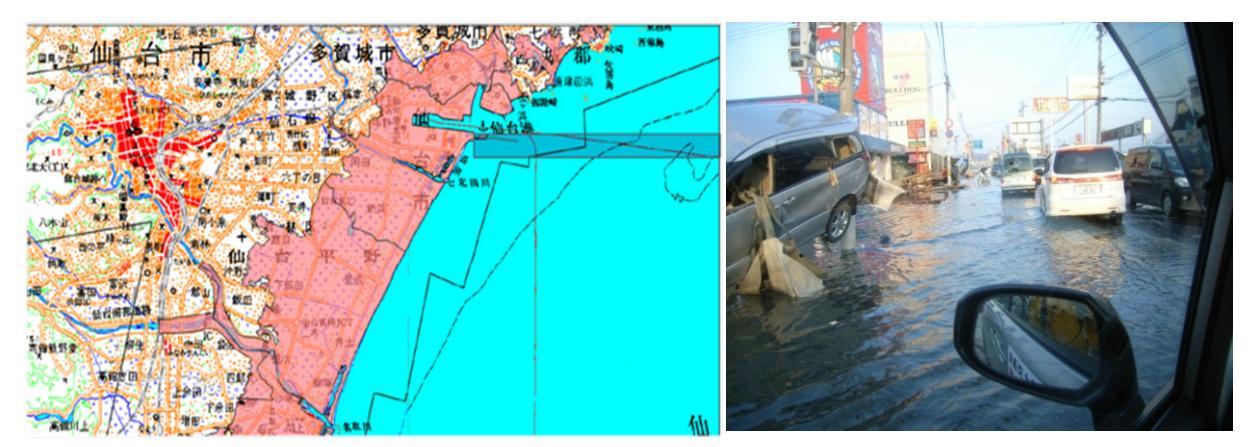
Fig. 8 (left) Inundated areas, Sendai Plain (by the courtesy of Geospatial Information Agency of Japan)

Fig. 9 (right) Inundation by ground subsidence, two days after the earthquake, Ishinomaki City, Miyagi Prefecture (by the courtesy of Tohoku Regional Bureau of MLIT)

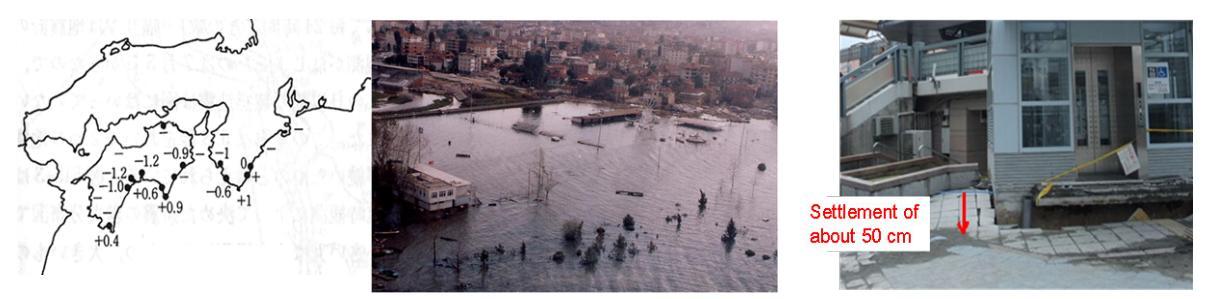
Fig. 10 (left) Ground subsidence and heaving (in meter) by the 1946 Nankai Earthquake (Kawasumi, H.)

Fig. 11 (middle) Submerged area in Gölcük due to ground subsidence during the 1999 Kocaeli, Turkey Earthquake (Yasuda, S.)

There have been many reported cases of ground subsidence in wide areas during the past earthquakes in Japan and abroad. At the time of the 1946 Nankai Earthquake, there was about 1-1.5 m of subsidence around Kochi City, as shown in Fig. 10, and the city suffered flood damage. There is a high possibility of the same type of ground subsidence occurring in the future due to the anticipated Nankai, Tonankai, and Tokai earthquakes. In the 1999 Kocaeli Earthquake in Turkey, ground subsidence occurred over a wide area along the Izmit coast, including subsidence of about 1.5 m at Gölcük (Fig. 11), where an area of 1 km² was inundated. The JGS dispatched a survey team to carry out a detailed investigation of the damage.

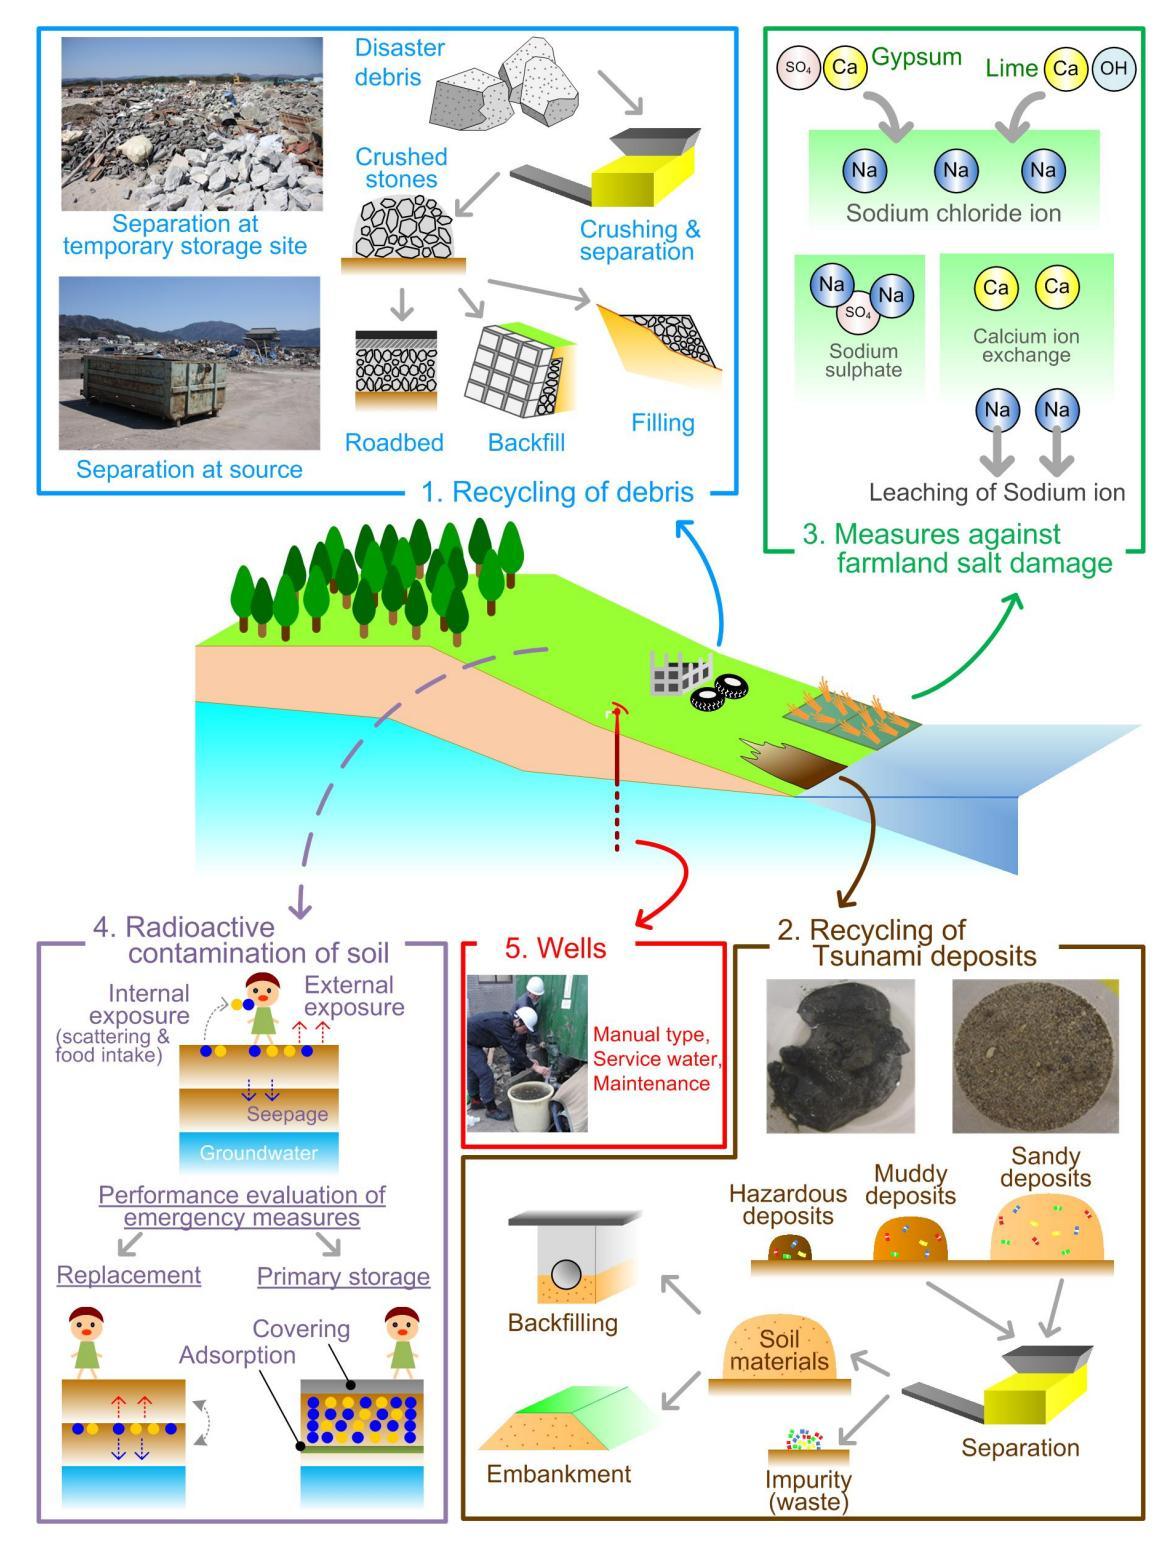
Fig. 13 Treatment of disaster wastes, tsunami deposits, and soil contaminated with salt and radioactivity (Endo, K.)

Knowledge of geotechnical engineering should contribute especially to a), b), d), and e) (Fig.

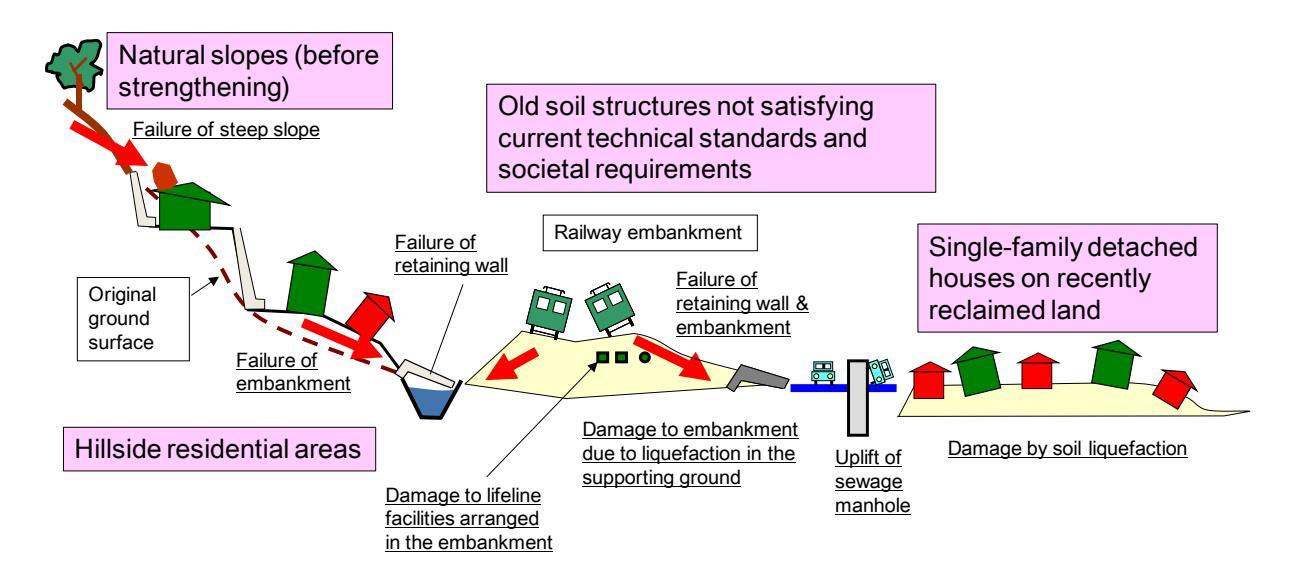
Fig. 14 Schematic diagram illustrating seismic damage in general in inland area

Although this situation is unavoidable historically, it has been promoted to a certain extent to introduce the seismic design, seismic risk assessment and strengthening of the soil structures as parts of public infrastructures. Yet, the current conditions were still far insufficient. In fact, the recent earthquakes damaged a great number of 'old soil structures that may not satisfy current technical standards and societal requirements' (i.e., embankments or soil retaining walls for roads, railways, housing lands, and dams of reservoirs, river/coastal dikes, reclaimed lands, facilities for drainage such as manholes or sewers, and undergrounding structures such as pipelines for agriculture), and 'unexamined/untreated natural ground and slopes'. Failure of those soil structures made a serious impact on society. (Figs. 14, 15, and 16)

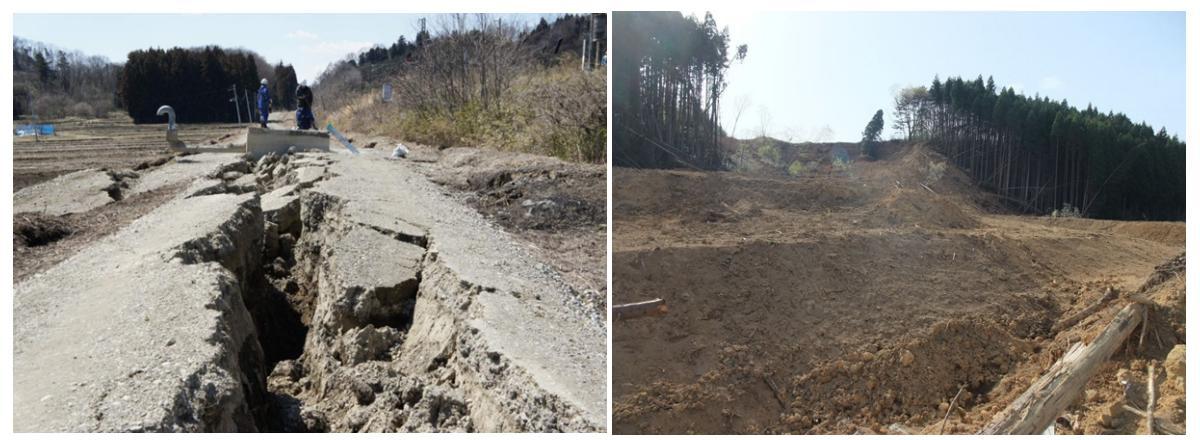
Fig. 15 (left) Damage to a main agricultural pipeline for a length of about 1.4 km due to uplift caused by liquefaction of backfill soil. The largest depth of opening was about 1.6 m (Mohri, H.)Fig. 16 (right) Failure of a natural slope, Hanokidaira, Shirakawa City (Yasuda, S.)

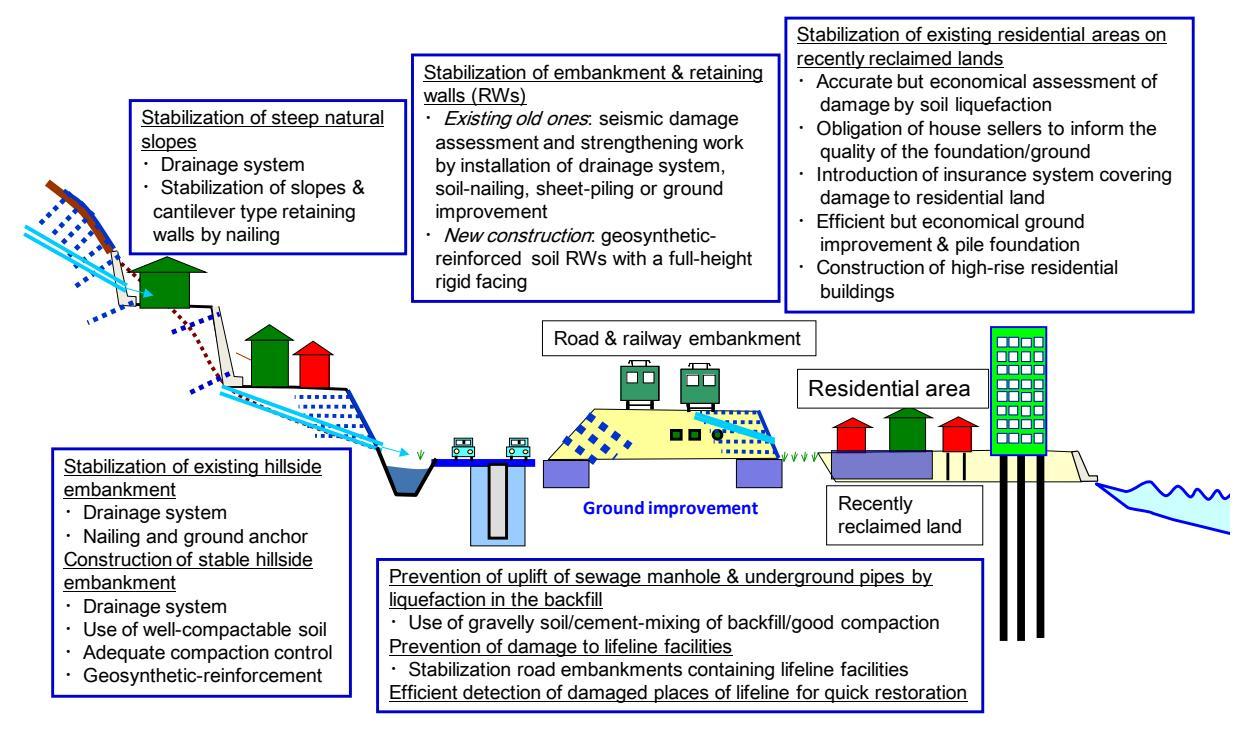
Fig. 17 Various examples of geotechnical engineering technologies to prevent geo-disasters

damaged soil structures / slopes to have a higher earthquake-resistance by using cost-effective methods, rather than restore these structures to their previous states that do not meet the today's standards. To this end, as shown in Fig. 17, it is necessary to utilize the latest geotechnical engineering, such as various ground improvement technologies or soil-reinforcing technologies, adding to basic technologies of appropriate compaction control of embankments, installation of drainage facilities and etc.
